# **Rolex Sydney Hobart Yacht Race 2024**

## **Review Committee Report**

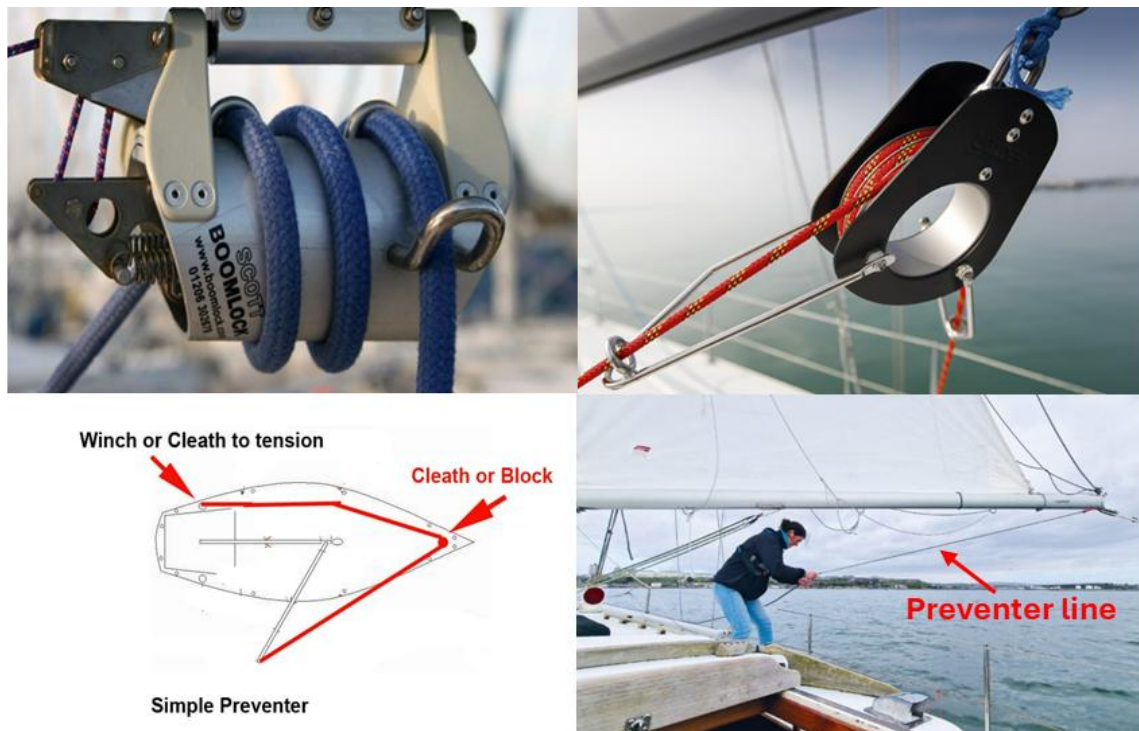
***Top – Boom brakes are friction-based mechanical devices affixed to the boom and controlled by a line while,***

***Bottom – Preventers typically comprise a line rigged at the end of the boom and led forward.***

100. In any event, neither device will prevent a 'crash gybe' but the consequences of a 'crash gybe' with a preventer introduces an additional danger point in that it will contribute to pinning the boat down and increasing the difficulty of righting the boat. Preventers also have a reputation for creating significant gear damage because of the extreme forces involved and the shock loads that can occur making many sailors wary of using them in hard running conditions.
