MIR-25-33

Collision of Multi-Purpose Carrier *BBC Africa* with Bulk Carrier *Common Faith*

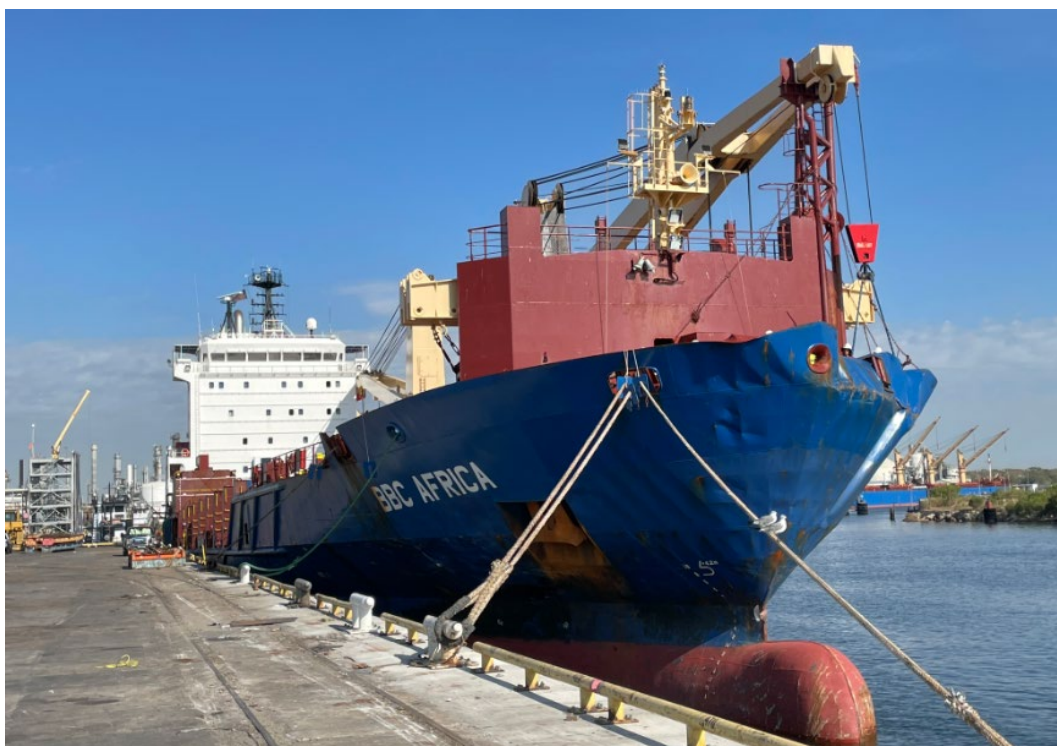
Figure 1. Multi-purpose carrier *BBC Africa* at Manchester Terminal, Houston, Texas, after the collision.

The total repair cost for *BBC Africa* was \$700,000. The bulbous bow, port side hull plating, and port forward quarter bulwarks and shell plating were damaged, but the class inspection found no internal hull or tank top breaches. Repairs performed in the shipyard in Swinemunde, Poland, were completed in November 2023. The class society surveyed and confirmed the repairs.

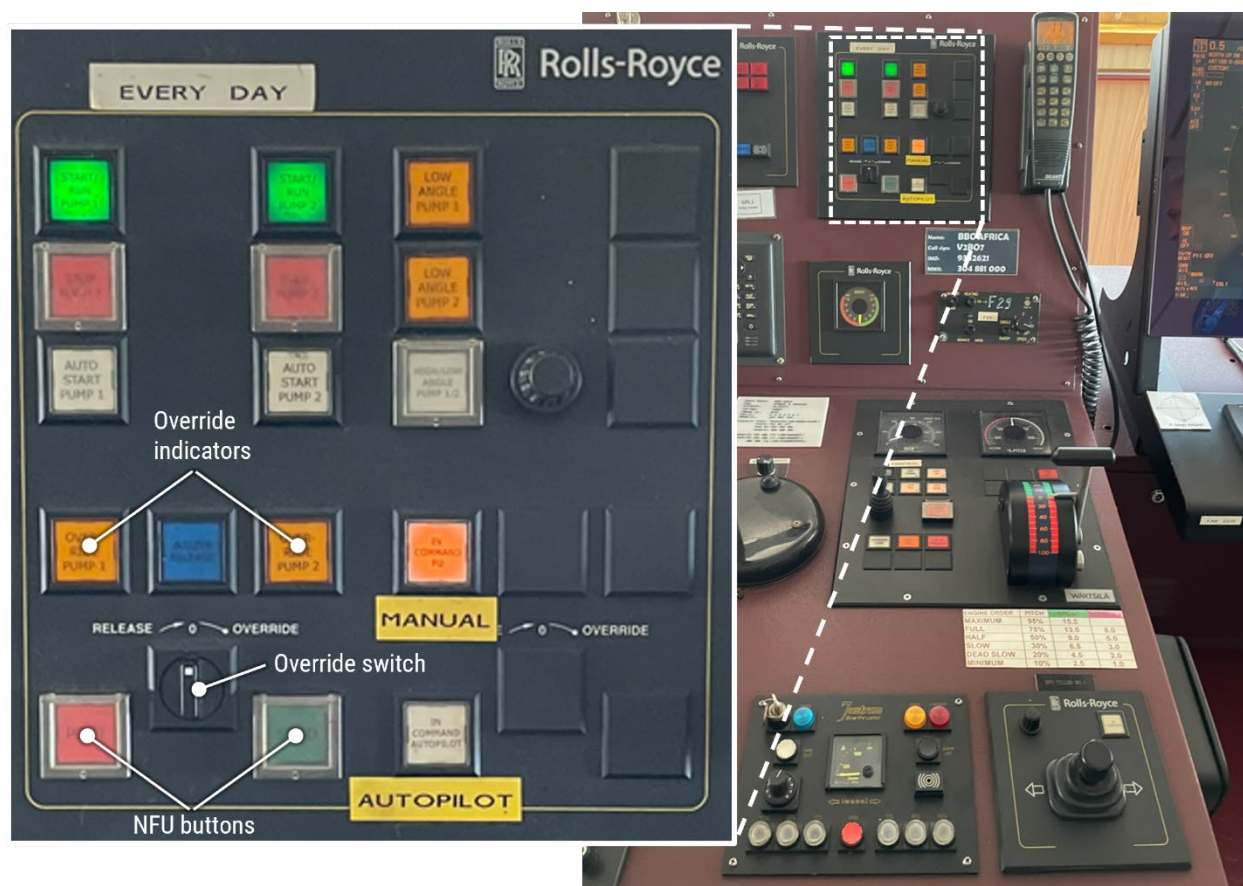
Just after the hard to starboard order, the chief officer noticed that the "in-command FU" button's light had switched off (indicating that the main control station no longer had control of the propulsion engine and steering). He told investigators that, at the same time, the rudder indicator display showed the rudder move "hard to port." He pressed the "in-command FU" button again, and the helmsman again attempted to turn the rudder to hard starboard. Both the helmsman and chief officer told investigators that the rudder indicator momentarily reacted, but then the "in-command FU" button's light again switched off and the rudder indicator quickly returned to a hard port position of 30°. The chief officer attempted again to take command by pressing the "in-command FU" button, without success (see figure 3).

Figure 3. *BBC Africa* main bridge control station. Inset shows the emergency override portion of the steering panel with its NFU buttons, override switch, and override indication lights labeled.

A steering control panel in the upper right-hand portion of the bridge main control console included auto-pilot mode, manual NFU, and emergency override mode (see figure 3). To switch to emergency override mode, the operator had to turn the override switch, flip up the protective cover on the NFU port or starboard button, and hold the button down while the rudder responded.

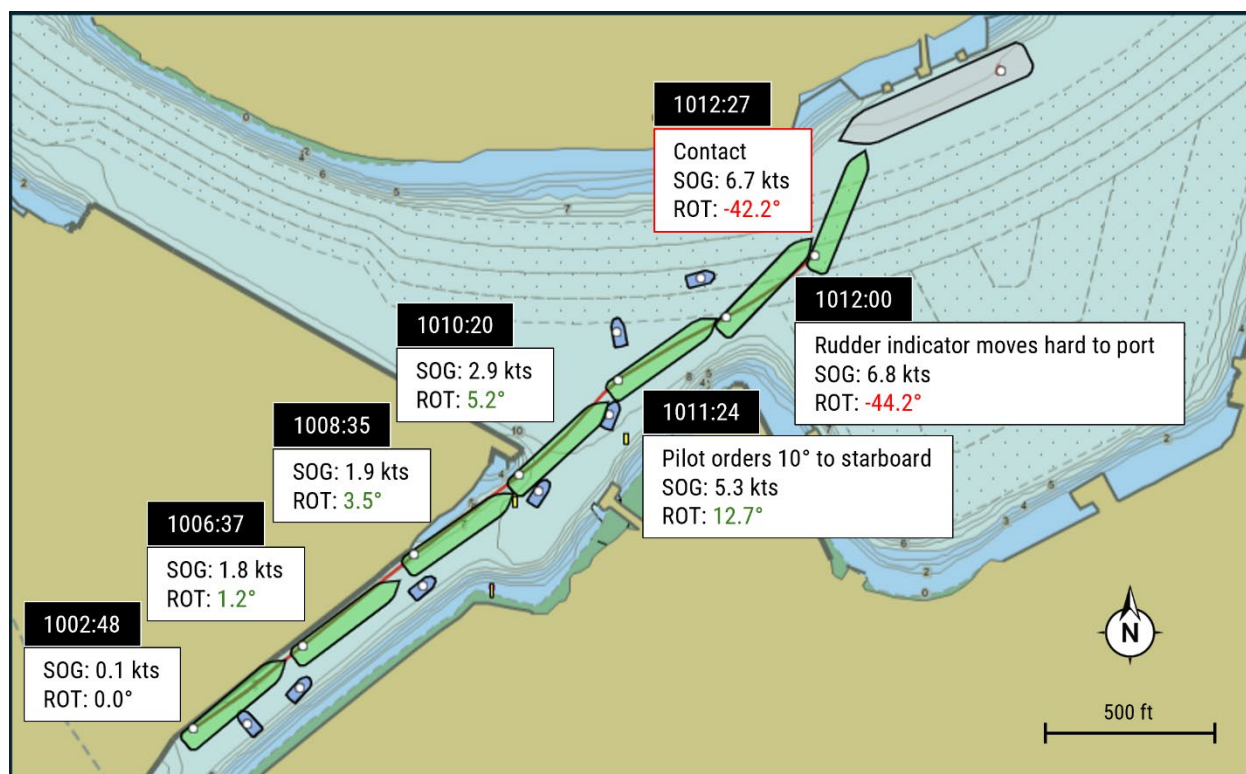
However, at 1012:00, the vessel continued, at 6.8 knots and with a heading of 044°, toward the Anderson Grain Terminal, where the bulk carrier *Common Faith* was docked, loading cargo. At 1012:27, traveling at 6.7 knots, the *BBC Africa* collided with the *Common Faith* (see figure 4).

Figure 4. *BBC Africa* trackline, showing speed over ground (SOG) and rate of turn (ROT), leading up to the contact with the *Common Faith*. (Background source: MadeSmart)

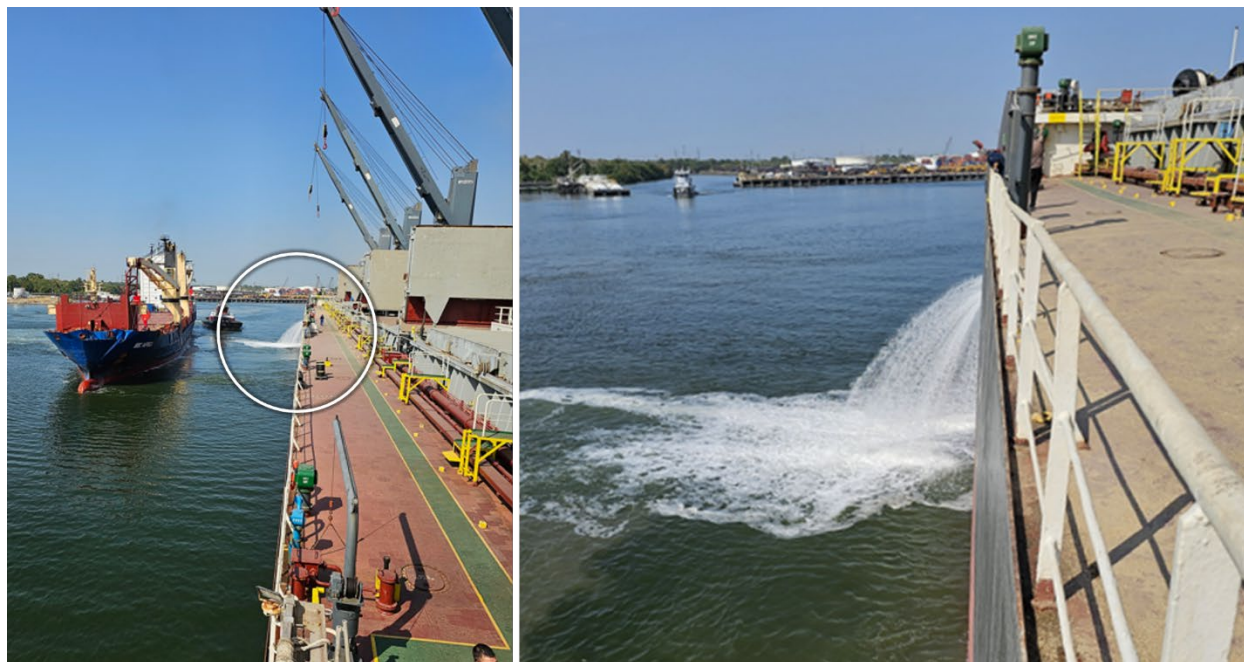
Damage to the *Common Faith* totaled \$475,000. The top of the port ballast tank was punctured, releasing ballast water into the harbor (see figure 5). Shell plating near the no. 1 port ballast tank was punctured and folded inward.

Figure 5. Left to right: *BBC Africa* (left) and *Common Faith* after the collision. *Common Faith* punctured port ballast tank spilling ballast water (circled; left photo). (Source: *Common Faith* master)

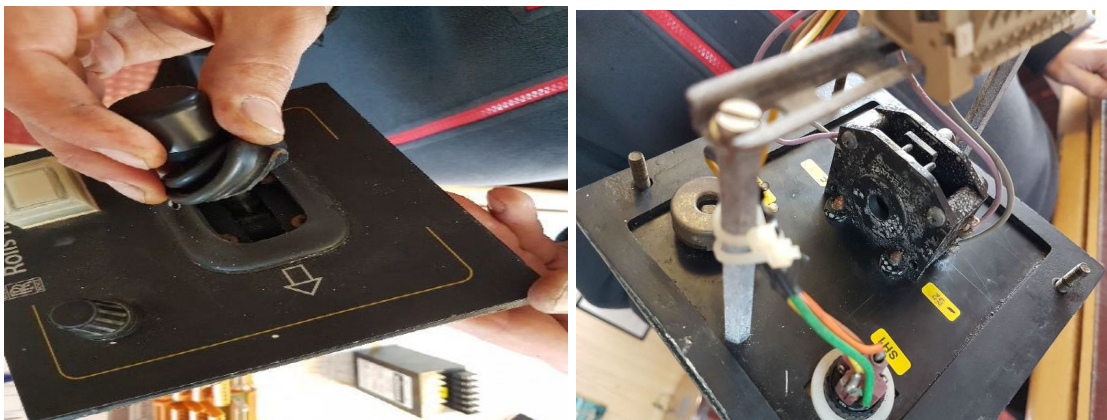
Further investigation determined the cause of loss of the signal of the steering control on the PS wing - the joystick (tiller) rubber had partly internal invisible cracks, thus the moisture was absorbed inside of controller unit and covered electrical processor, as consequence - loss of electrical signal.

Figure 6. *BBC Africa* NFU steering tiller of the port wing control station showing damaged rubber boot and corroded/defective micro switch. (Source: Kongsberg Service Report)

Following the collision, technicians from the manufacturer and investigators inspected and tested the mechanical and electrical components of the three control stations and control system panels. None of the procedural tests replicated the same loss of steering scenario experienced by the crew. However, tests found three components that could have led to the steering failure: the port bridge wing tiller, the power supply transformer in the control cabinet located behind main bridge, and the push button relays to take "in command" status when requesting control. The operator replaced all three components following the collision, so investigators were not able to examine them further (the company also replaced these components on two other vessels with similar steering control systems). Additionally, after the collision, the steering gear manufacturer released a Safety Bulletin on switch failures in the bridge wing tillers. The Bulletin specifically noted that micro switch failure could lead to unintended rudder movements. Therefore, based on the rudder's movements and the post-casualty testing and inspection, the steering control failure was likely due to the bridge wing tiller micro switch failing.

On October 16, the vessel owner replaced the *BBC Africa*’s primary NFU steering control tillers on both bridge wings, two termination cards, the power supply transformer, and bridge wing “in command” push buttons—all with original equipment manufacturer (OEM) parts (see figure 6). The company also replaced the same components on two of its other vessels with similar systems.
