MIR-25-33

Collision of Multi-Purpose Carrier *BBC Africa* with Bulk Carrier *Common Faith*

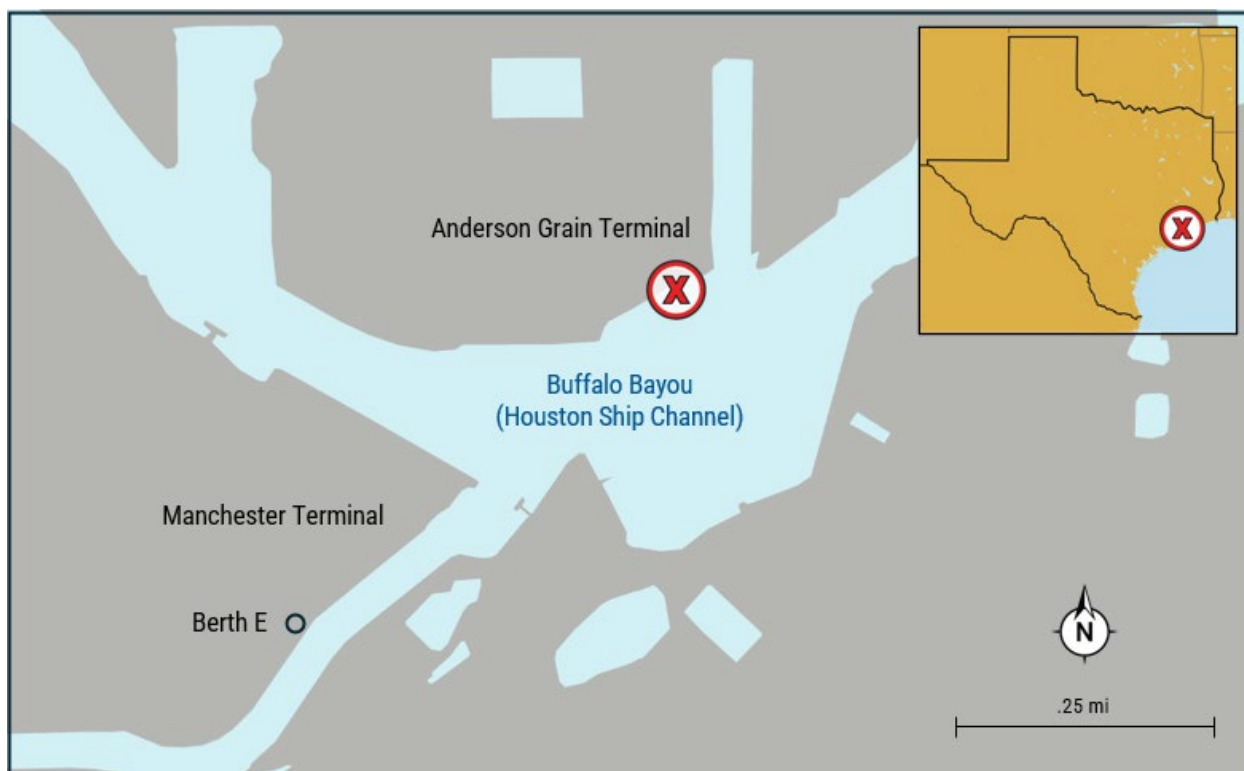
Figure 2. Area where the *BBC Africa* collided with the *Common Faith*, as indicated by a circled X. (Background source: Google Maps)
